ENTHUSIAST'S RESTORATION MANUAL SERIES

SECTION 2. 'UNWINDING' A GEARBOX

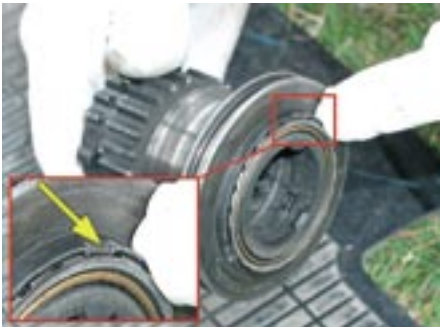
5-2-2. The ring for the second and third gear selector fork was staked onto the synchro hub when the gearbox was built (inset, arrowed). The problem is that the three stakings may not hold, especially on the later gearboxes.

The ring is threaded with a right-hand thread onto the synchro hub and, when it unscrews, the synchro hub will slide forward, into the third gear, which makes the gearbox engage third gear.

The symptoms of the problem are that you can engage reverse okay, if you put the lever in what was neutral, but if you can then find any other gear, the vehicle will be in both first and third, and will be immovable. Don't struggle with the gearstick - you'll only cause more problems.

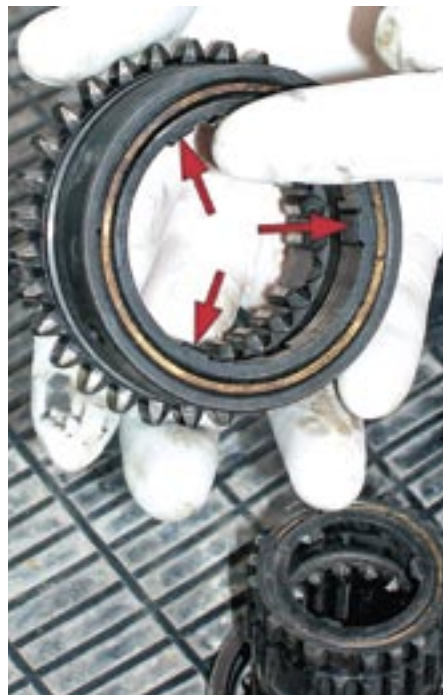
5-2-3. This ring is inside the synchro hub first gear, at the opposite end of the hub to the ring that unscrews itself.

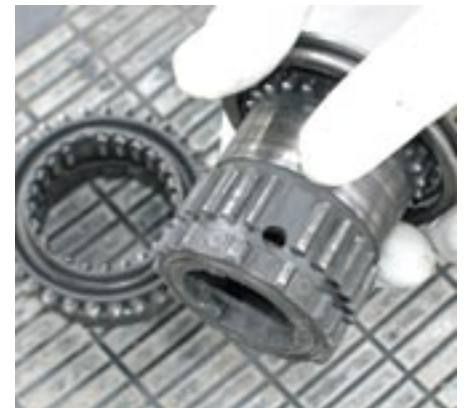
5-2-4. This internal ring has three dogs on it which slide in three slots on the second and third synchro hub. The dogs can come free of the slots, and the ring on which they are located can turn so that the dogs no longer line up with the slots. You then have the job of realigning the dogs with the slots before you can get the ring back on the synchro hub. (In other words, before you can push the first gear synchro hub onto the second and third gear synchro hub.)

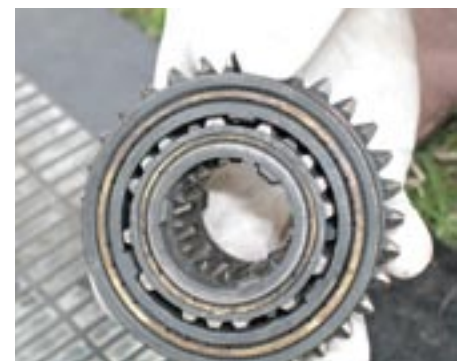
5-2-5. This picture shows one of the dogs located correctly in its slot.
